Federal Aviation
Administration

ZODIAC CH 601 XL AIRPLANE SPECIAL REVIEW TEAM REPORT JANUARY 2010

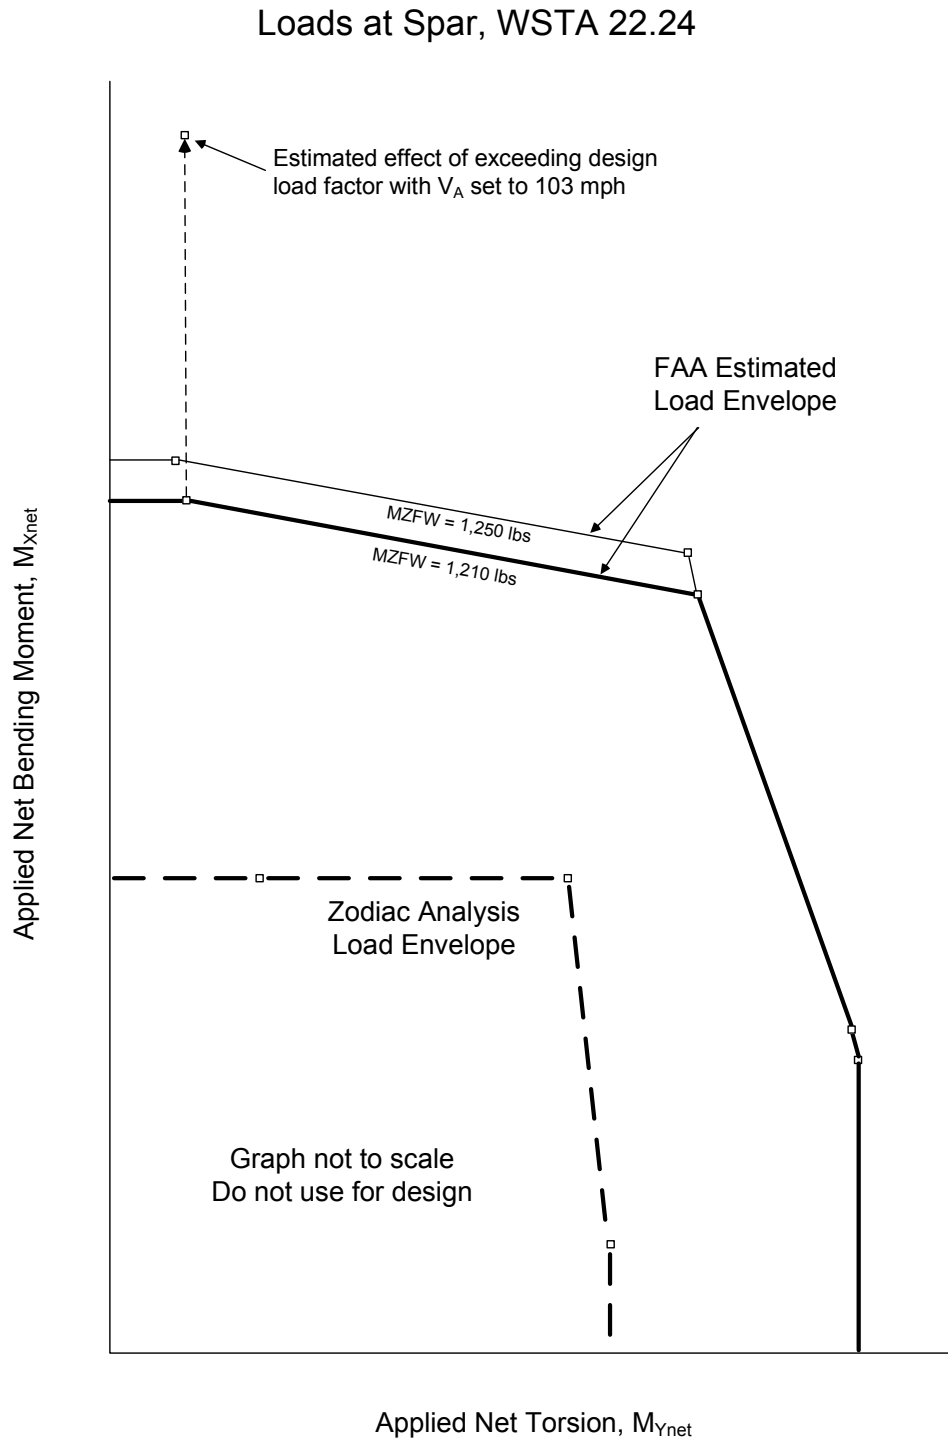
Figure 1: Comparison of FAA Estimated Loads with 'Zodiac CH 601 XL Stress Analysis and Tests'

- The amount of lift produced by the portion of the wing planform covered by the fuselage. The manufacturer’s analysis assumes the wing planform covered by the fuselage is as effective in producing lift as an adjacent portion of exposed wing planform. This assumption may not be conservative and may be noncompliant with the ASTM F 2245 § 5.1.1.2 requirement that ‘...these loads must be distributed to conservatively approximate or closely represent actual conditions.’

- The correct definition of the maximum zero fuel weight (MZFW). The manufacturer’s analysis defines the MZFW as the maximum takeoff weight (MTOW) minus full fuel. This definition is incorrect. The intent of the MZFW is to design the wing for the condition where airplane weight is at a maximum but the wing fuel tanks are only partially full. Because the fuel load is alleviating for wing bending loads, using the proper fuel load to determine MZFW is important.

For the CH 601 XL, the MZFW case is the condition where two occupants (190 lbs each, according the ASTM standard) are added to the empty weight of the airplane (830 lbs). Then sufficient fuel is added to the wing tanks to reach MTOW. For the CH 601 XL, the MZFW is 1,210 lbs (830 + 380 lbs) and the MTOW is reached with 110 lbs of fuel, instead of the zero fuel weight used in the manufacturer's calculations. This could lead to the structure being designed to a lower capacity than needed.

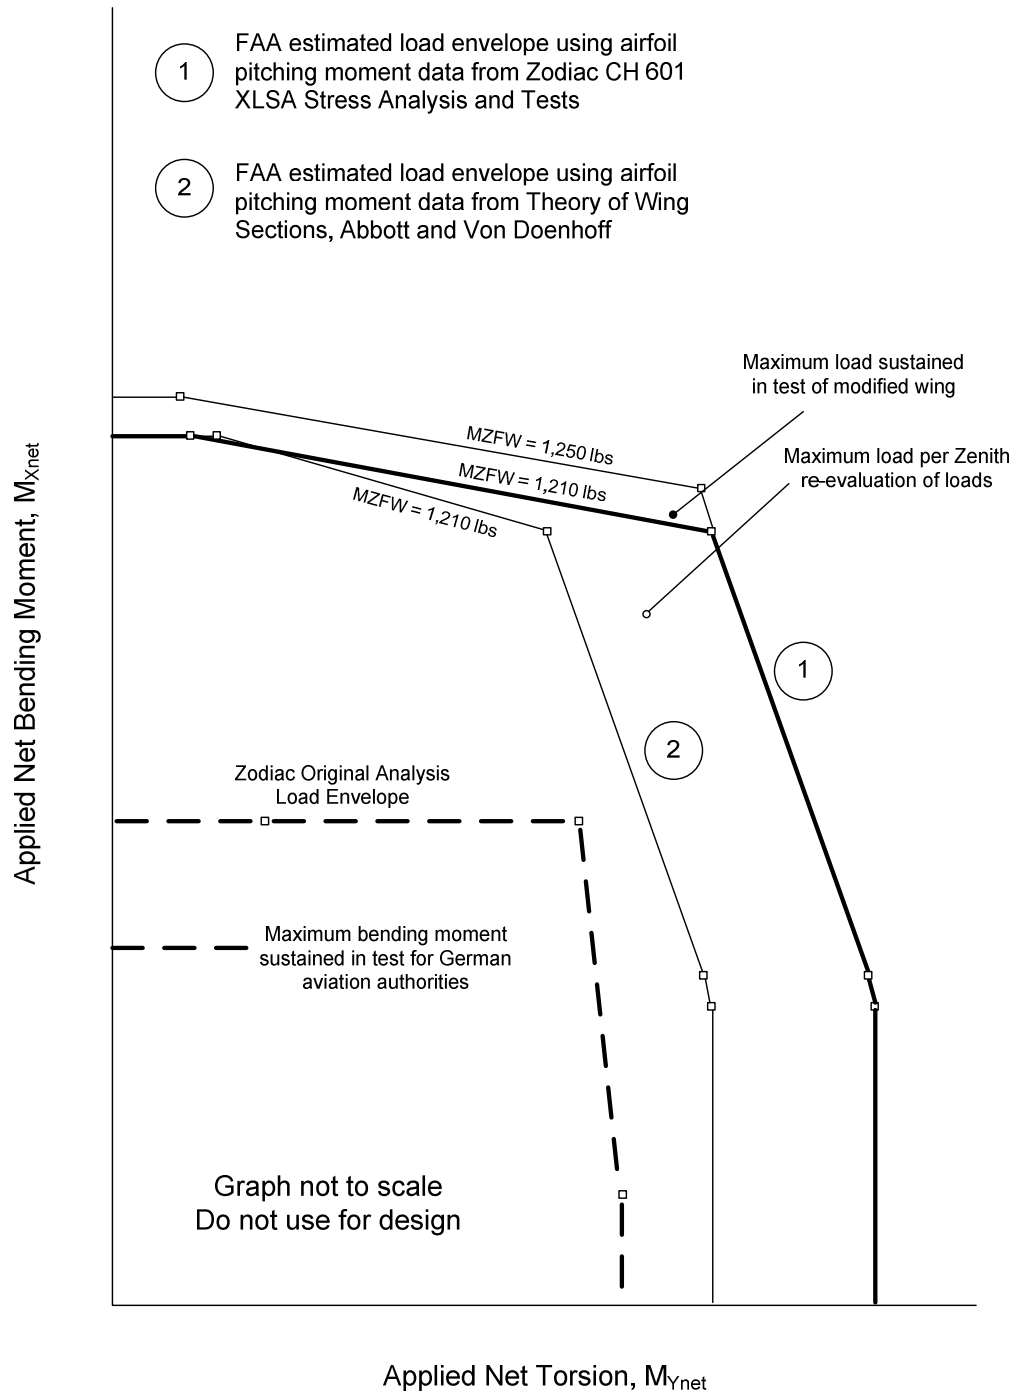
Figure 3: Revised Zodiac Analysis and Static Test Wing Design Loads

The manufacturer successfully tested the modified wing structure to loads higher than determined in their revised analysis. The wing structure did not fail at the ultimate test loads. However, the wing attachment bolts were bent and the attachment bolt holes were elongated, indicating there was permanent damage to the structure at these loads. We have depicted the loads from the manufacturer's revised analysis and static test in figure 3.

Despite disagreeing with our position on several significant issues, the maximum bending moment achieved in the static test is only a few percent below our estimated maximum required bending moment. The maximum torsion load achieved in the test may only be a few percent below our estimated maximum torsion provided the manufacturer can justify the airfoil pitching moment data with applicable test data. It is possible that if the manufacturer had continued the static test to structural failure, the ultimate test load could have equaled or exceeded FAA estimates of the required load envelope.

- The manufacturer stopped the static test of the modified structure approximately five percent below the FAA's load estimates required for ASTM compliance. At the time of this report, the manufacturer was continuing to make modifications to the wing structure and the drawings referenced by the safety directive to provide further improvements. The manufacturer should consider additional structural testing and analysis once a final design is reached to demonstrate the new wing meets the ASTM standards.

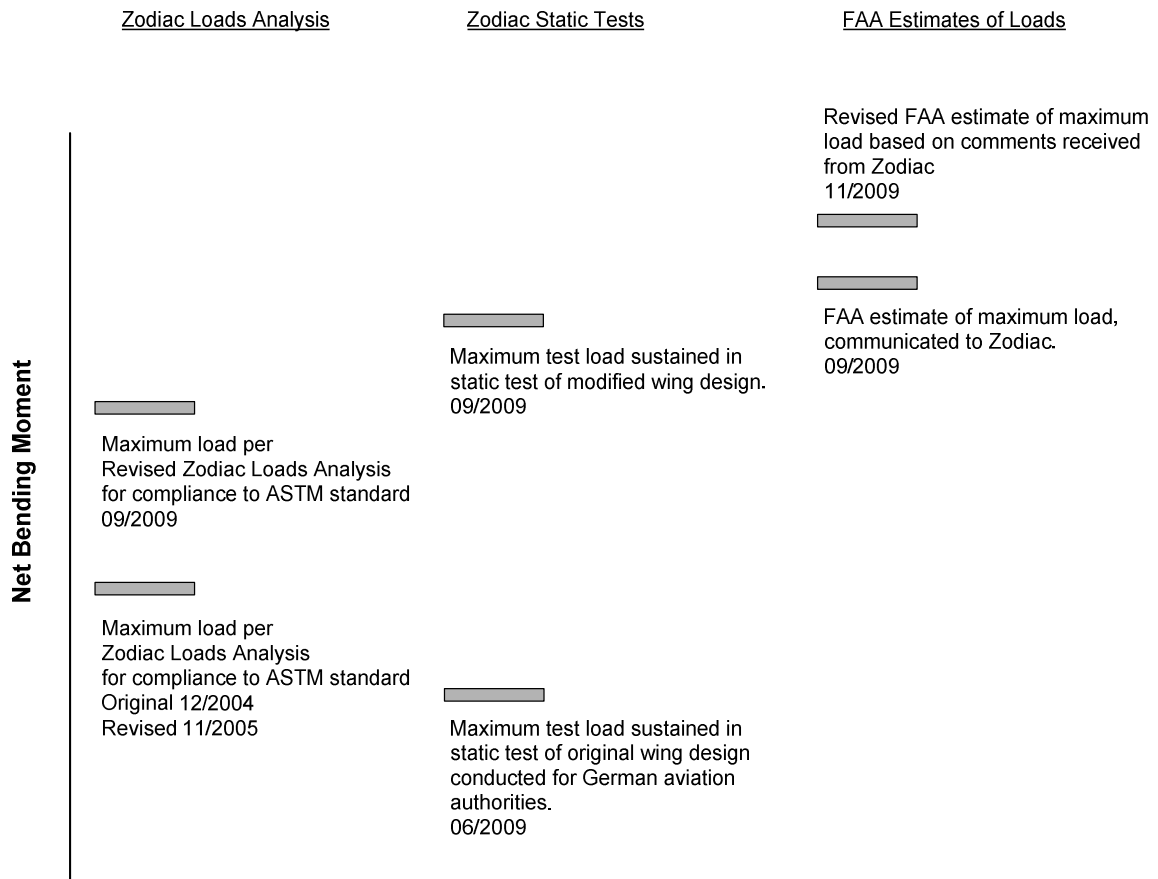
Figure 4: History of Zodiac Wing Structural Loads Analysis and Tests

Figure 4 presents a history of the manufacturer's loads analysis and static testing. We provide this information to provide a time line of the manufacturer's structural analysis and testing.

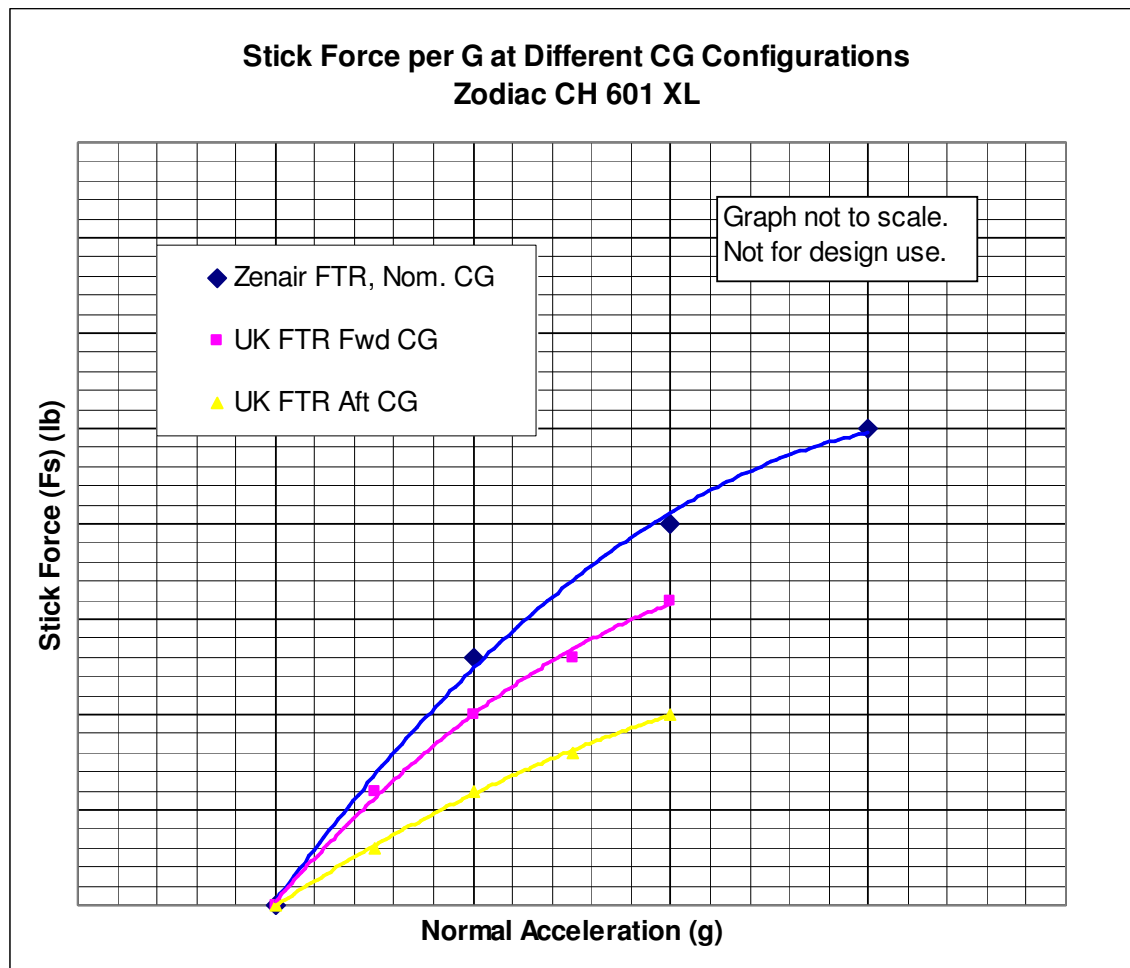
Figure 5: CH 601 XL Stick Force per g Evaluation

A manufacturer's flight test report dated November 2005 was used as the primary source of data for the FAA to evaluate the stick-force characteristics of the CH 601 XL against the FAA accepted version of the ASTM International, F 2245-07a, 4.5.2.2. The results were also compared to 14 CFR Part 23 § 23.155. The FAA found the manufacturer's Flight Test Report data is compliant with the ASTM standard. Although not required to comply with 14 CFR part 23, we found the data also meets the standards of 14 CFR Part 23 § 23.155(a) and (c).

Though not required to do so, it appears their tests followed the guidance provided by AC 23-8B. However, when applying this guidance to aft center of gravity data to match compliance with 14 CFR Part 23 § 23.155(a), Figure 5 shows the stick force at limit load appears to extrapolate to a value slightly less than the 15 pound minimum requirement at limit load. Though the CH 601 XL does not have to comply with 14 CFR Part 23, the data does indicate that stick force gradients may not be acceptable for aircraft that are intentionally or unintentionally flown outside the POH center of gravity limits. This is simply presented for regulatory comparison, as 14 CFR Part 23 § 23.155(a) is not currently reflected in the ASTM standards at any center of gravity configuration.

- The current ASTM Standard F2245, 4.5.2.2 is actually more stringent than its 14 CFR Part 23 § 23.155(c) counterpart and may remain unchanged.
- The ASTM standard does not currently require a minimum control force at the limit load factor. ASTM International should amend their standards to require a minimum control force at limit load factor, similar to concepts defined in 14 CFR Part 23 § 23.155(a).

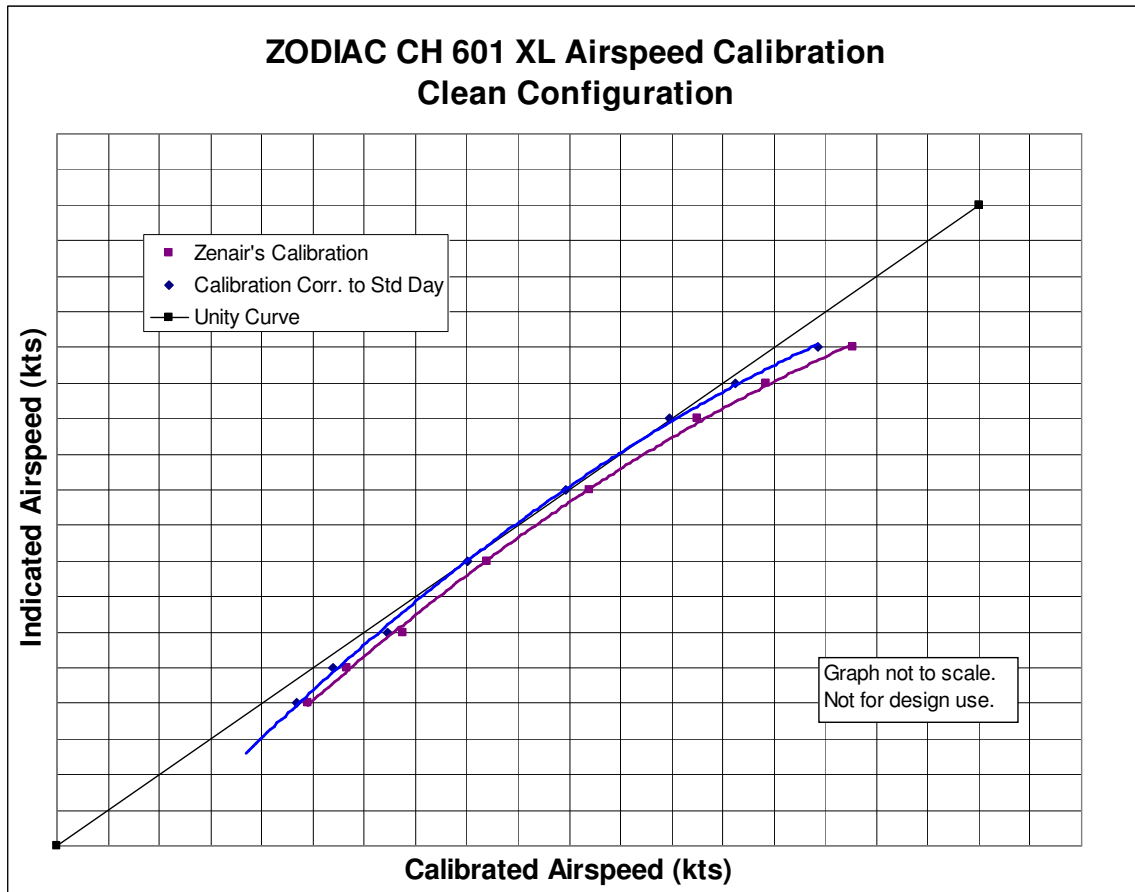
Figure 6: Standard Day Correction Effects on CH 601 XL Airspeed Calibration

Regarding stall speed, the manufacturer's flight test report determined the flaps up stall speed to be 35 knots indicated airspeed (KIAS) (40 mph) which was reported as 43 knots calibrated airspeed (KCAS) (50 mph). In reality, it was 43 knots true airspeed (KTAS) (49 mph), which after correcting to standard day conditions; the stall speed is calculated to be 41 KCAS (47 mph). The manufacturer's Airplane Flight Manual (AFM) reported a 43 knot (49 mph) flaps up stall speed indicating that standard day corrections were not applied to the flight test data.

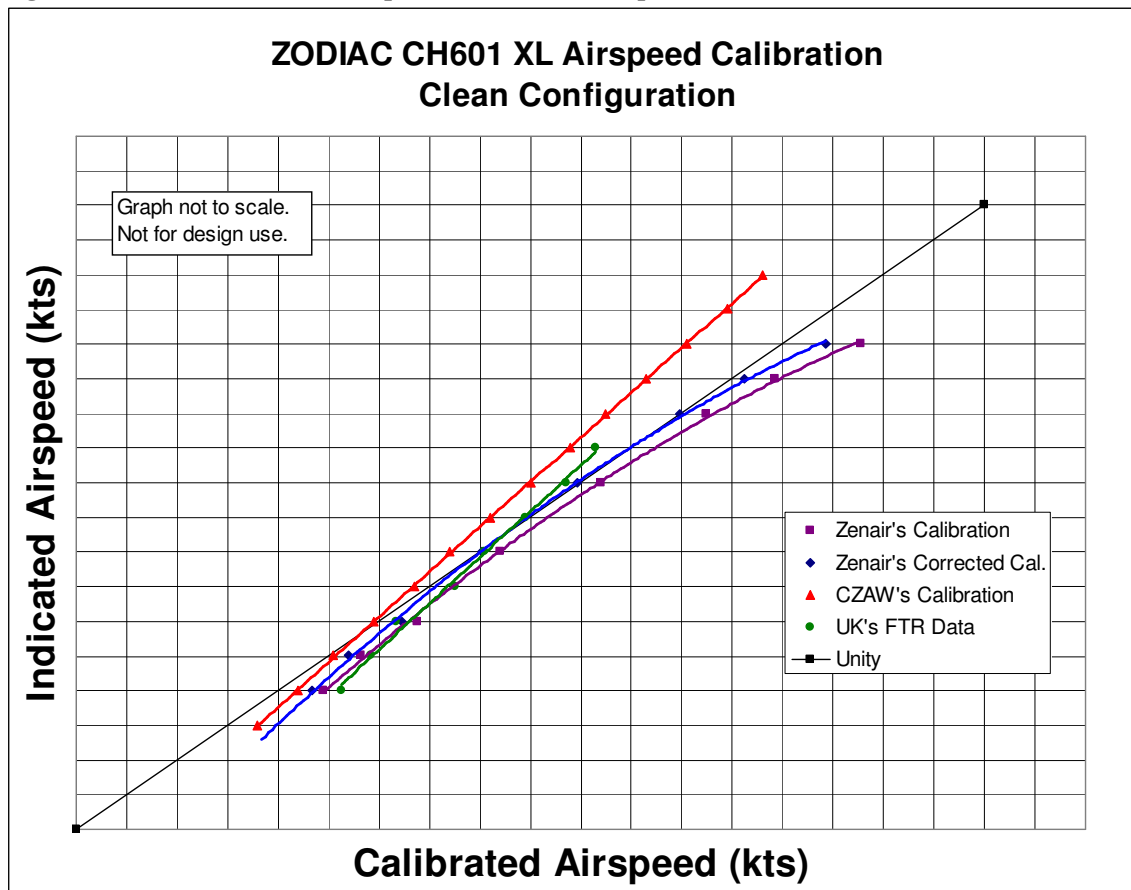
Figure 7: Zodiac CH 601 XL Airspeed Calibration Comparison

A comparison was made between CZAW and the manufacturer's airspeed calibrations. The calibrations were substantially different in both shape and magnitude. Without the flight test report, it is impossible to say which calibration is correct assuming that both designs are identical. Therefore, the potential to overspeed the aircraft exists. However, as part of the UK LAA flutter mitigation flight test program, an airspeed calibration was conducted and the results were overlaid with those from the manufacturer and CZAW, as seen in Figure 7. (Note: We have removed the actual airspeed values from figures 6 through 8 to protect the manufacturer's proprietary information and data.)

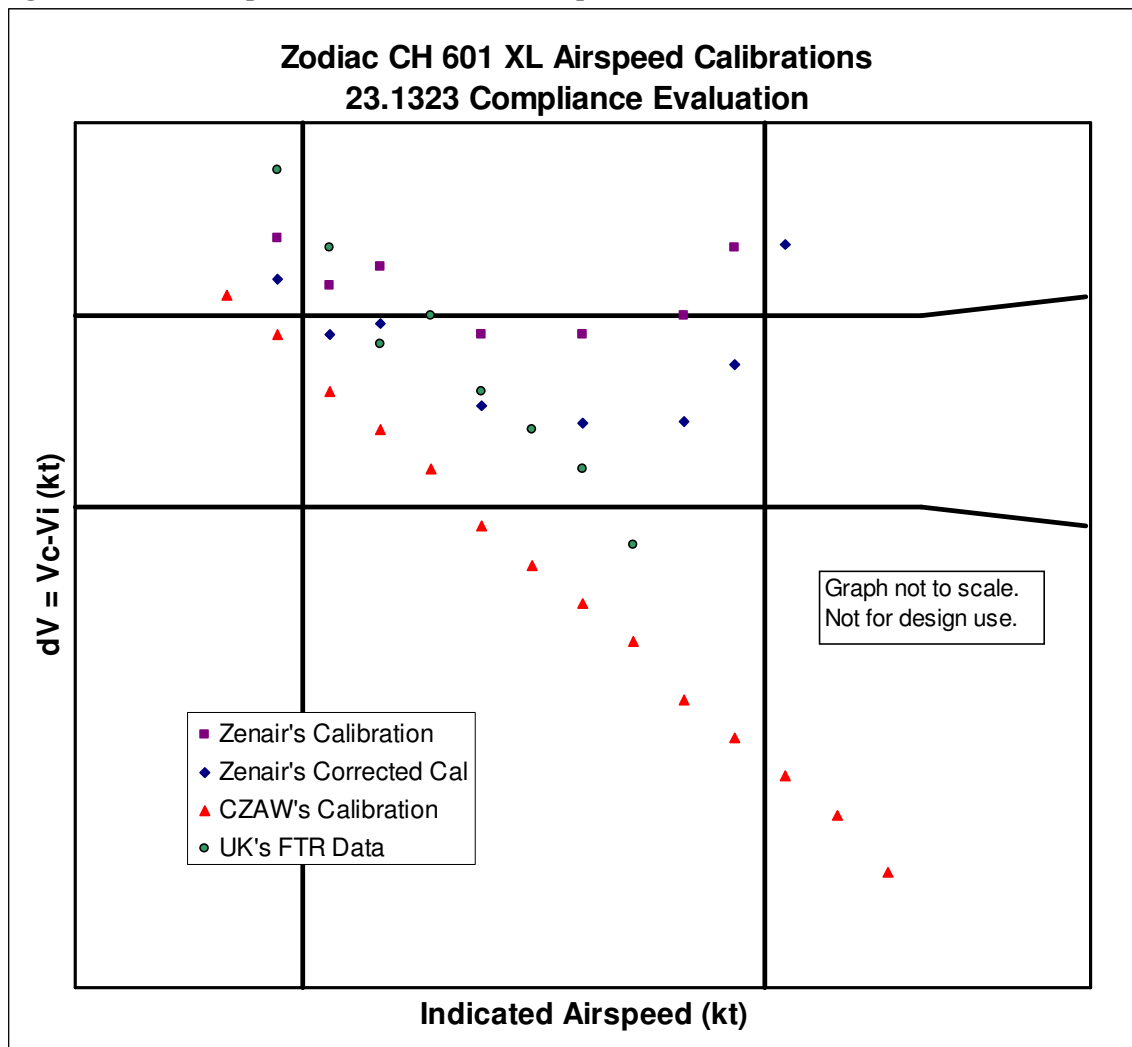
Figure 8: Zodiac Airspeed Calibration Evaluation per 14 CFR Part 23 § 23.1323(b)

The UK LAA's flight test results are similar in magnitude to the manufacturer's data, but trend with CZAW's data making the comparison inconclusive. Using a different approach to determine the validity of the calibration data, a 14 CFR Part 23 § 23.1323(b) analysis was performed on these data sets and shown graphically in Figure 8. It should be

To evaluate the airspeed error per 14 CFR Part 23 § 23.1323(b), the error dV , must be less than ± 5 knots or 3% bounded by a lower airspeed of $1.3V_{S1}$ to a maximum airspeed of V_{NE} . Using the manufacturer's values, this means that to meet 14 CFR Part 23 § 23.1323(b), all the applicable data needs to fall in the enclosed ± 5 knot rectangle.

With these criteria in mind, the manufacturer's original calibration did not meet 14 CFR Part 23 § 23.1323 until after correcting for standard day temperature conditions. For comparison, neither CZAW nor the UK LAA's data meets 14 CFR Part 23 § 23.1323, though they are not required to do so. However it is unusual for a low speed aircraft like the CH 601 XL to need a -24 knot static source error correction, indicating a potential error in the calibration methods used. If corrected improperly, this large airspeed error could translate into approximately a 2.8g load difference at maneuver speed for the CH 601 XL and CH 650. This evaluation suggests the need for an ASTM standard similar to
