NATIONAL TRANSPORTATION SAFETY BOARD

REAR SPAR DAMAGE AGNOS, AR 12 PHOTOGRAPHS PART 4

Aircraft: Zenair Zodiac 601XL (experimental)

NTSB#: CEN10FA042

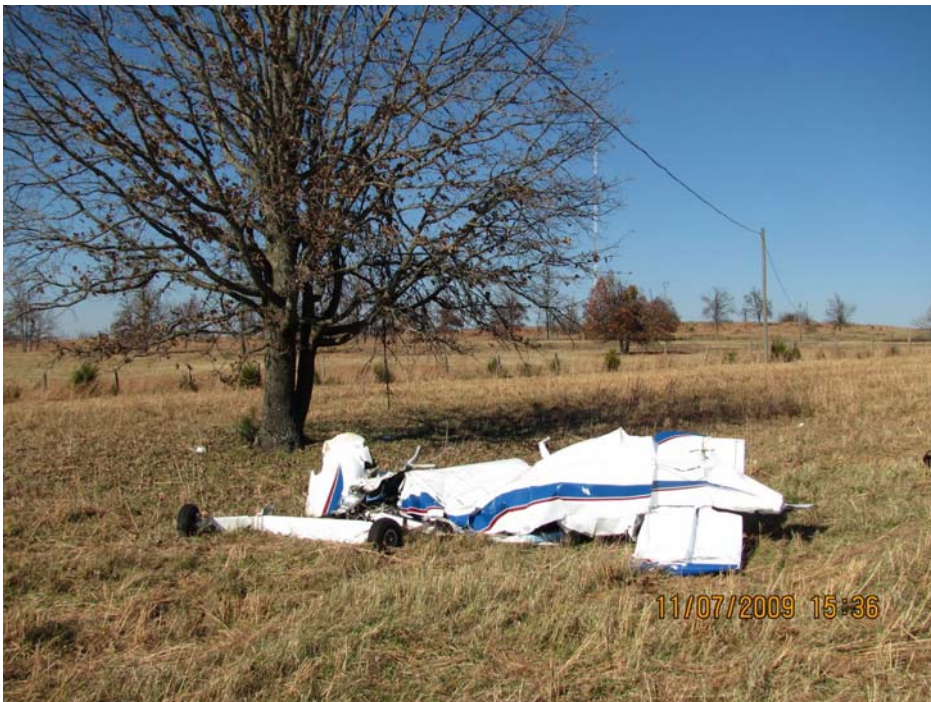
Both wings had separated from the fuselage. The horizontal stabilizer remained attached.

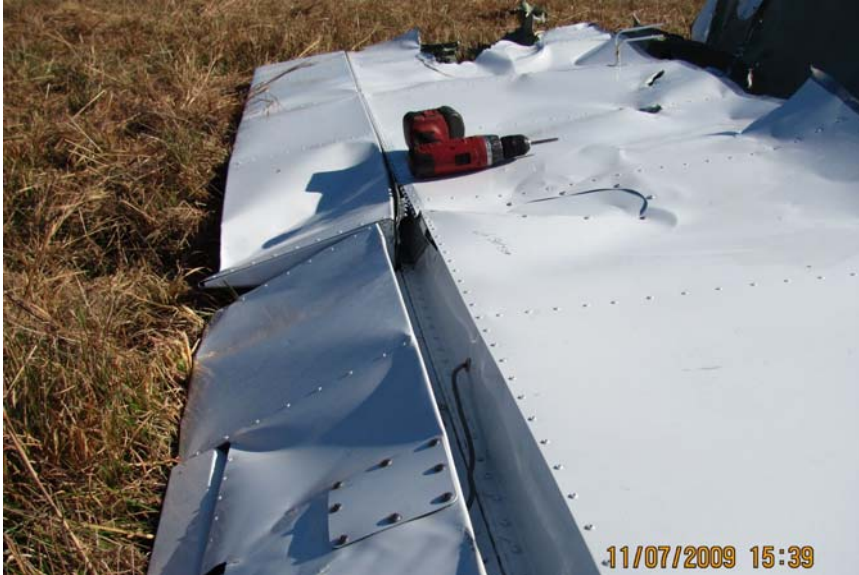
Bottom of the left wing.

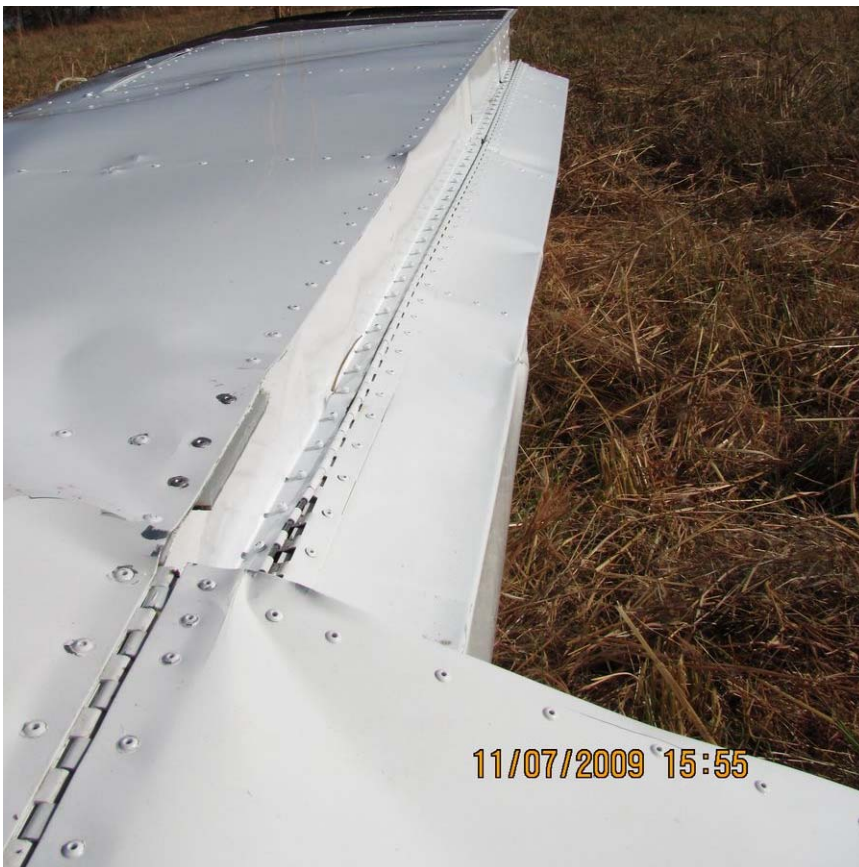
Top of the left wing.

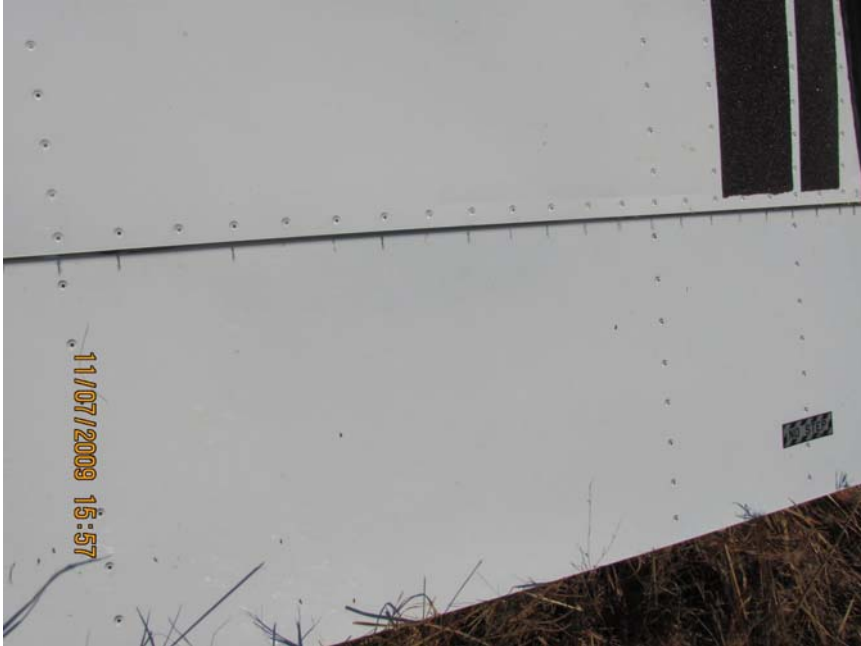
In some cases, only photographs of the external surfaces were available. In the Agnos, AR accident, buckling and scoring of the flap hinges and flaps were also noted.

Score marks on top of flap, left wing.

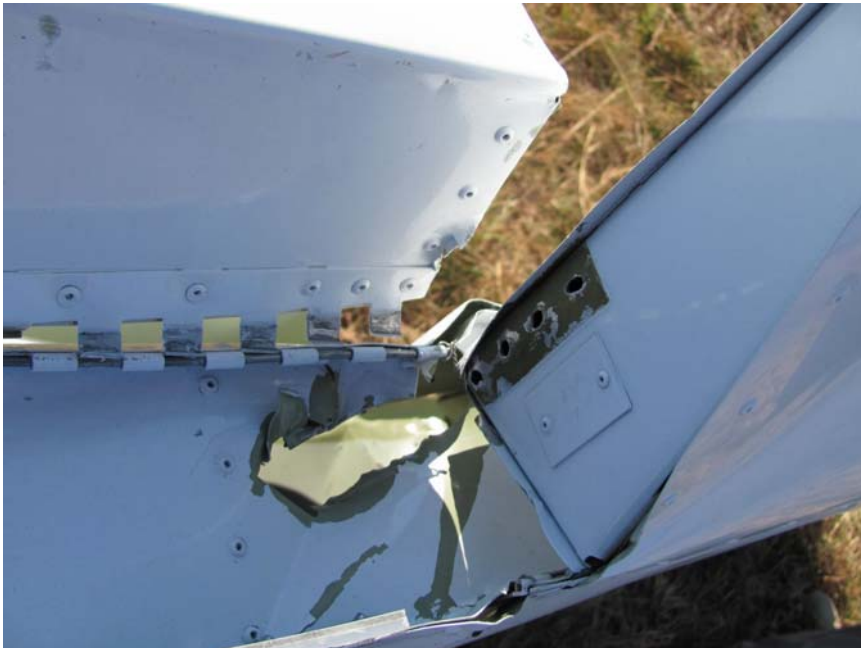
Typically, the compression buckling of the lower spar cap was at the lower edge of the hole that allowed the aileron push rod to pass through the rear spar web. The compression buckling of the upper spar cap was several inches inboard of the flap/aileron junction.

Compression buckling of top and bottom rear spar cap, left wing.

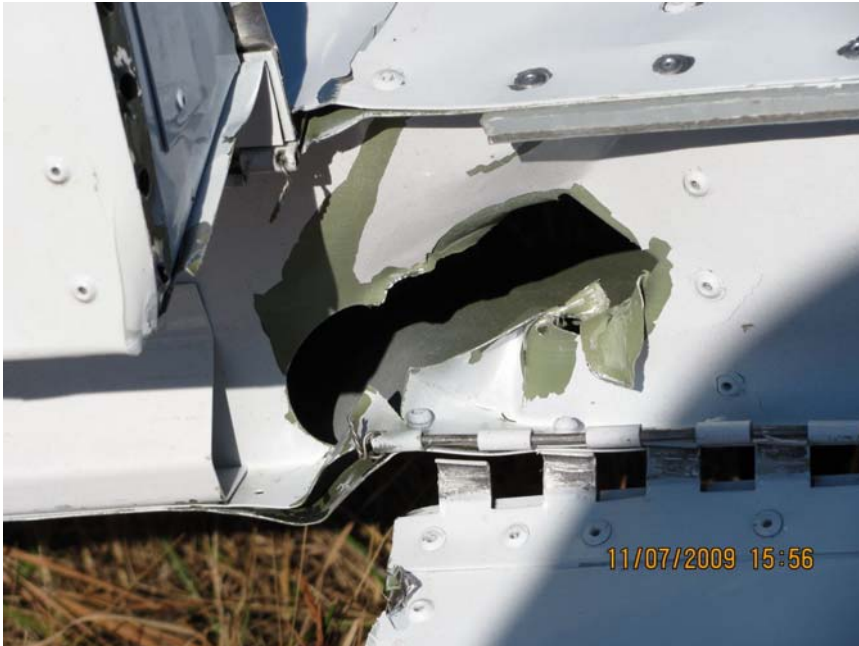
Another view of compression buckling on top and bottom of rear spar, left wing.

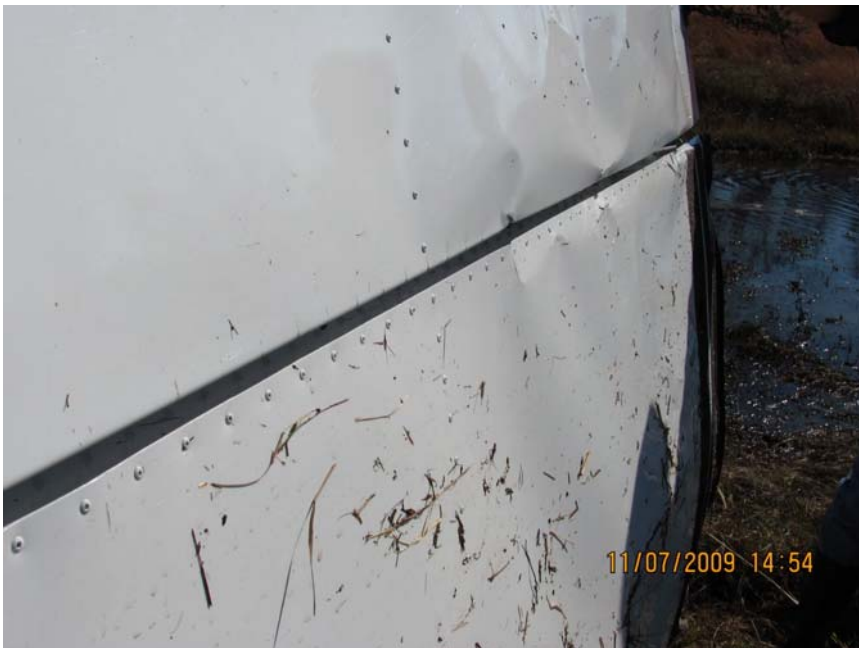
Top of right wing, score marks on top of flap.

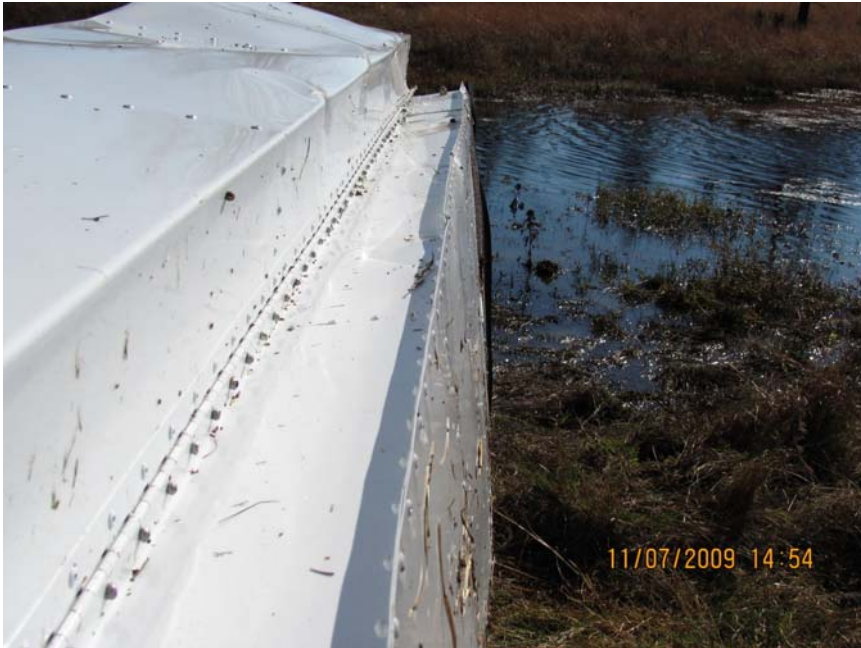
Top of right wing.

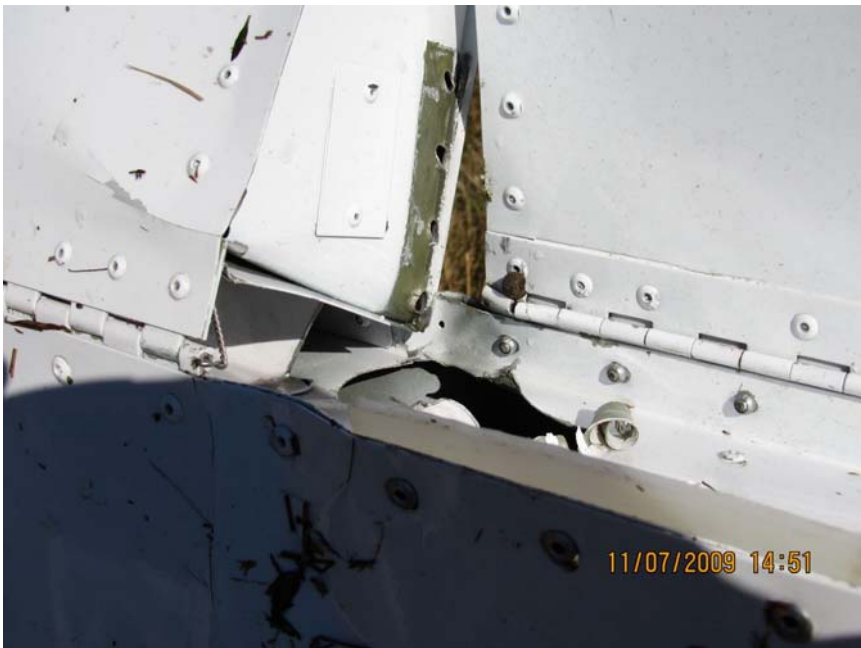
The Agnos, AR accident: both wings separated from the airplane. The aileron bellcranks, pushrods, and aileron attach fittings separated, were pulled through the wings and remained with the fuselage, attached by the cables.

Right aileron attach fitting.

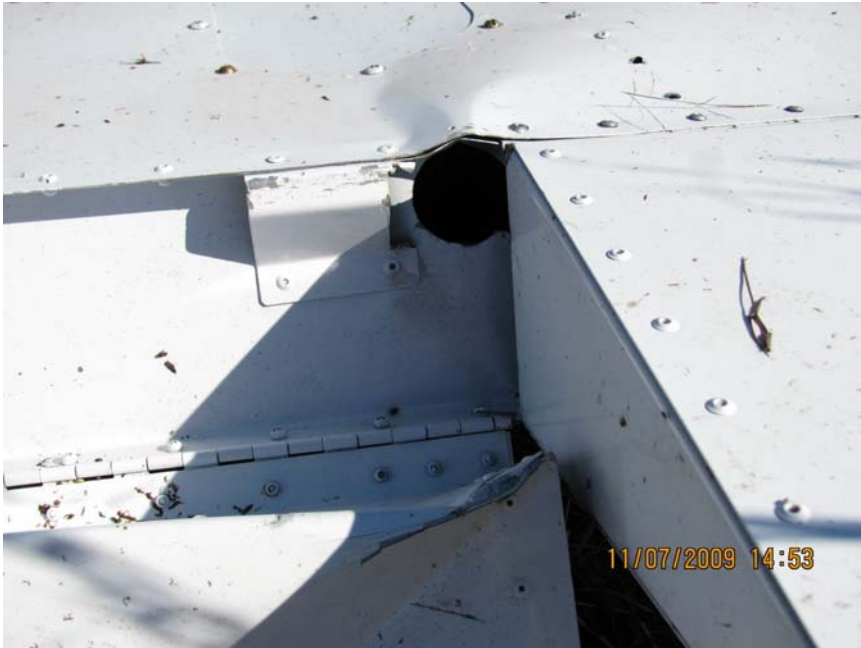
Rear spar, right wing.

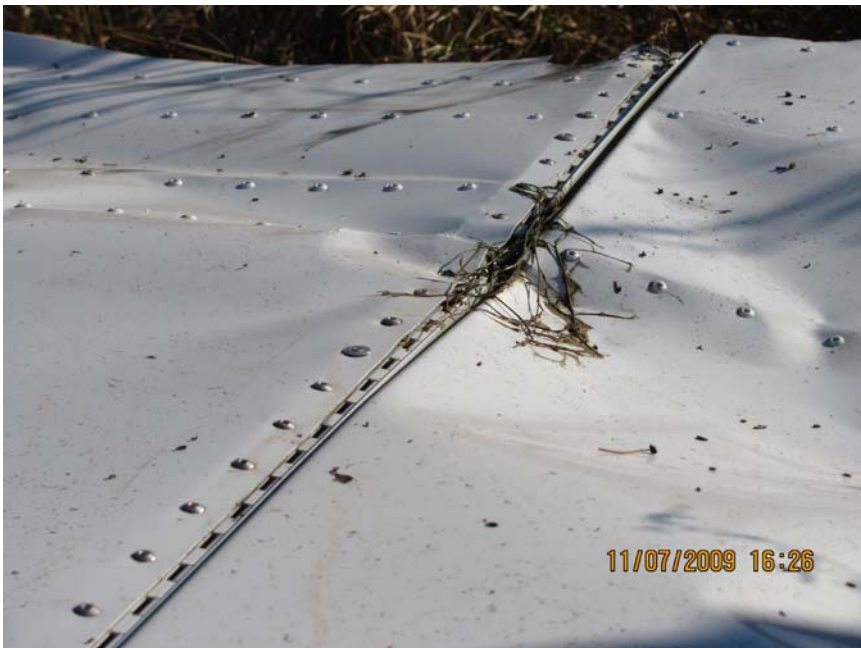
Bottom of right wing. Buckle at mid-span of right flap.

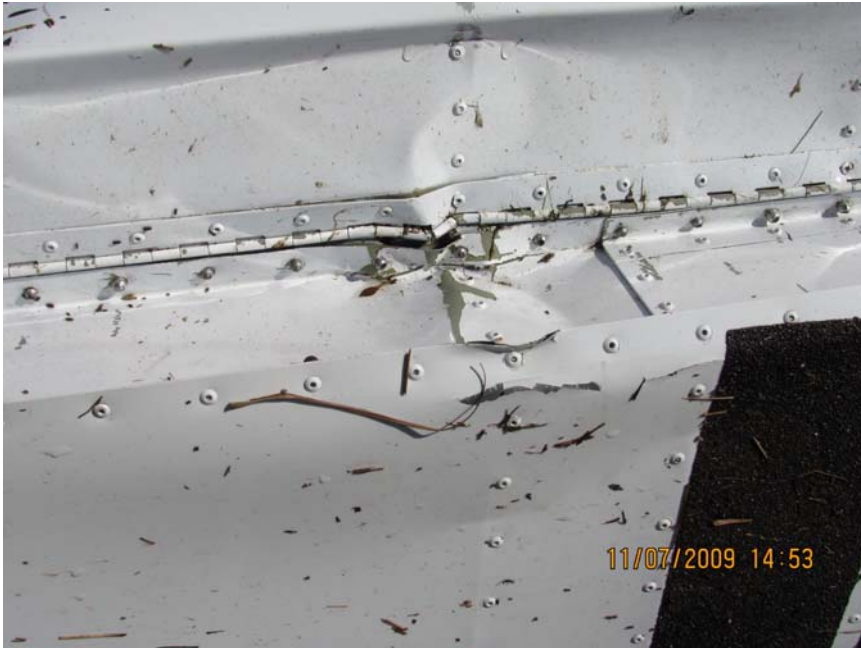
Bottom of right wing, lower rear spar. Buckle near mid-span of right flap.
